# Composite Self-sensing Thermal Sprayed Coatings for Pipeline Corrosion Prevention and Mitigation

F. Azarmi<sup>1</sup>, Y. Huang<sup>2</sup>, S. Abuali Galedari<sup>1</sup>, and Xiao Liang<sup>2</sup>  
 Department of Mechanical Engineering<sup>1</sup>  
 Department of Civil and Environmental Engineering<sup>2</sup>  
 North Dakota State University, Fargo, ND 58108-6050

This project was awarded to “Fardad Azarmi & Ying Huang” in order to develop and evaluate an innovative composite self-sensing thermal sprayed coatings to prevent, inhibit or mitigate, and manage pipeline corrosion for on-shore buried metallic transmission pipelines.

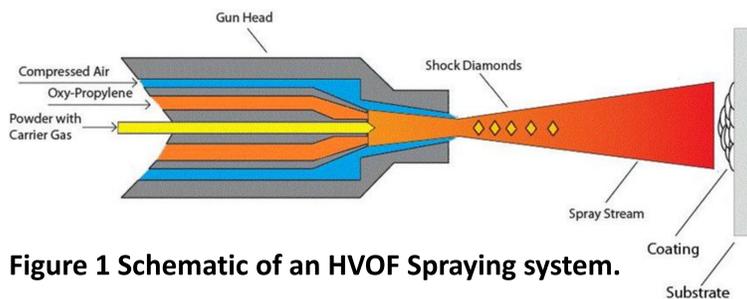
Figure 1 Schematic of an HVOF Spraying system.

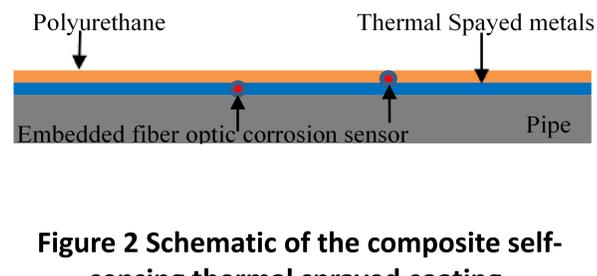
Figure 2 Schematic of the composite self-sensing thermal sprayed coating.

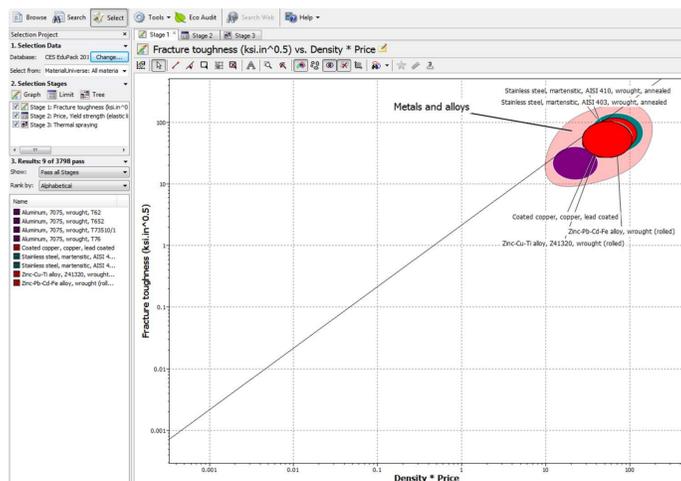
Figure 3 Materials selection chart.

Coating samples with embedded Fiber Bragg grating (FBG) sensors have been prepared and evaluated for the proof of concept. Different temporary set-up and masking system was designed to protect and fix the FBG sensors during spraying process. Materials selection method indicated that *stainless steel, copper* and *zinc* alloys are the optimum materials for corrosion protection.

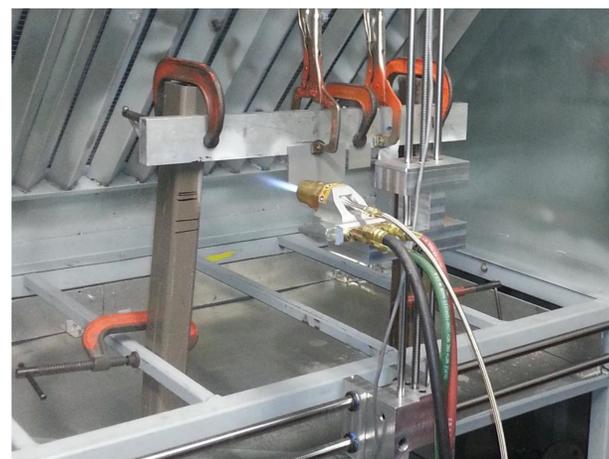
Figure 4 HVOF Spraying process.

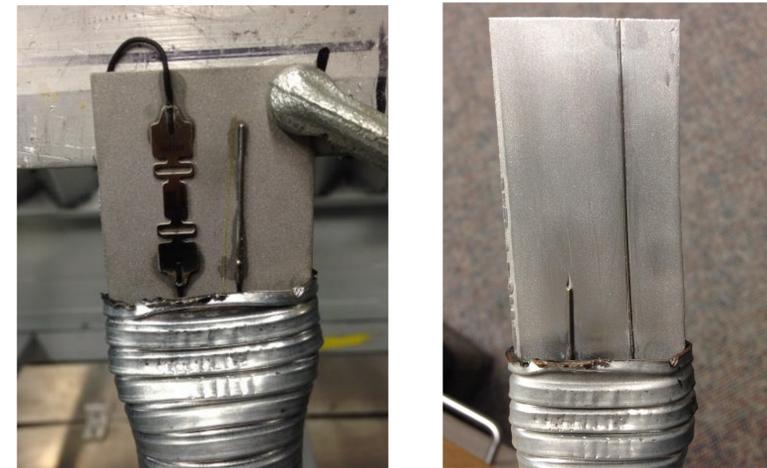
Figure 5 Two different temporary sensor set-up for spraying.

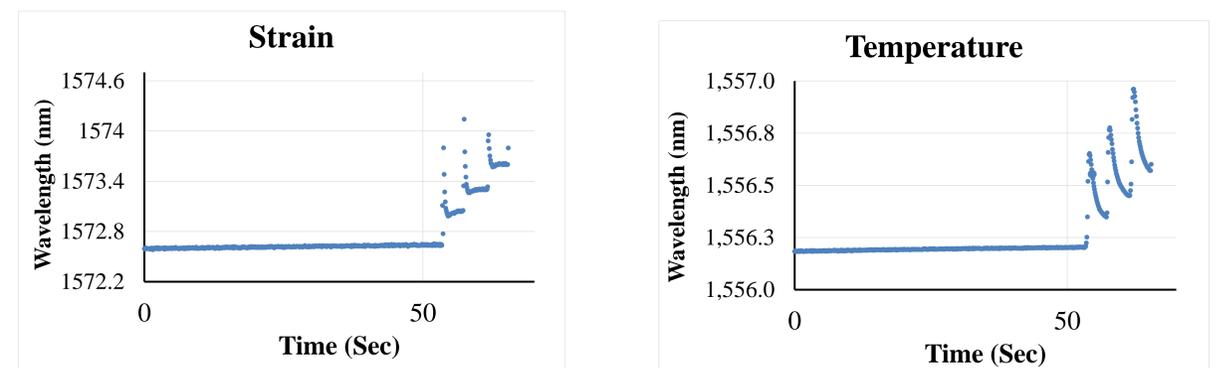
The wavelength were obtained from strain and temperature sensors.

Figure 6 Collected wavelengths during the spraying (left) strain and (right) temperature.
